APPENDIX 2

LISTED BUILDINGS AND SCHEDULED MONUMENTS WITHIN THE CONSERVATION AREA

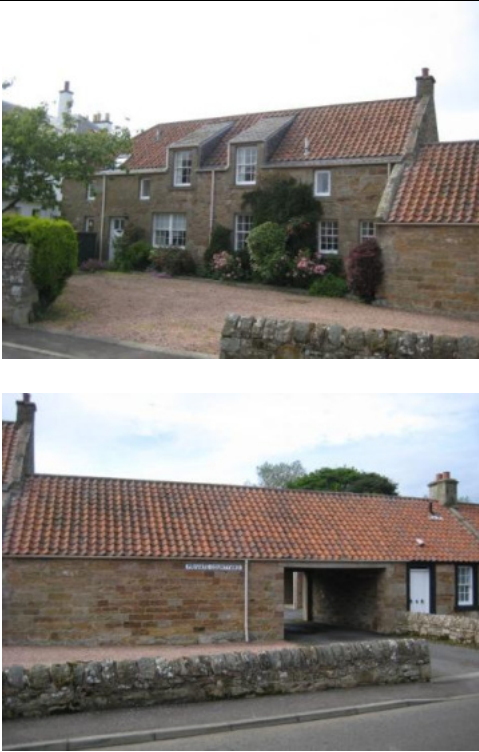
Item No.	Address	List description and Statutory Listing Category	B	 	<p>Farm buildings now completely altered and converted to residential use with loss of horse mill. Former farmhouse cement rendered and painted brilliant white.</p>
8734	Kingsbarns Farm, Main Street and North Street	House modernised early 20th century, 2-storey 4-window harl and slate with porch: farm - buildings unaltered 18th and early 19th century, rubble and pantile, octagonal horsemill on N, S range to North Street 2-storey (now reroofed in asbestos) with inset triangular pediment, single-storey wing and cottage now converted to garage.	B	 	<p>Farm buildings now completely altered and converted to residential use with loss of horse mill. Former farmhouse cement rendered and painted brilliant white.</p>

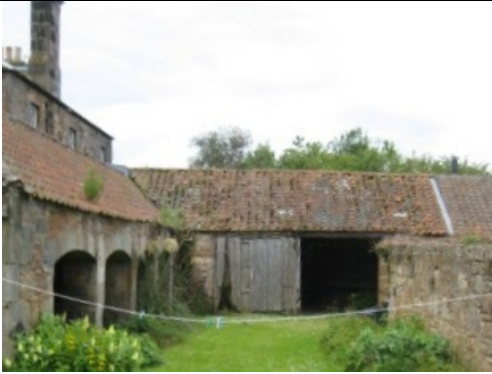
8736	North Quarter Steading, Main Street	Early 19th century. Single storey rubble with droved dressings, loft at N Threshing Mill section, segmental cart-shed arches, pantiled. Horse-mill is now roofless.	C(S)	 	Most buildings now converted to residential use with loss of horse mill. Now includes a large new development built within curtilage. Cart shed and threshing mill buildings remain, unaltered.

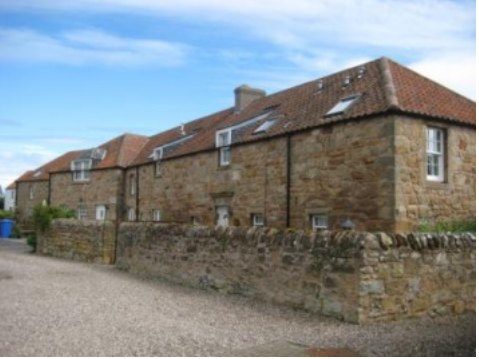
8737	The Library, Main Street	Dated 16 W (') RW 90 at boldly moulded doorpiece on W frontage to farm court. Altered 1911, door inserted on E. 2-storey, harled, piended pantile roof of late date.	B

Residential conversion. Blocked up window and door openings only reminder of former village hall/reading rooms use. Fore stair and other features removed.
8741	Daisybank, North Street	Late 19th century. Single-storey and attic 2-w indow and centre door, snecked rubble w ith chamfered dressings; slated. 2 canted dormers.	C(S)

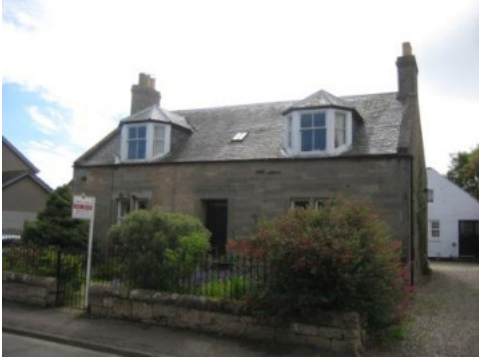
8740	Smithy, North Street	Early 19th century. Single-storey 2-w indow rubble and pantile, brick chimneys, later brick addition: complete and in use.	B

Residential conversion. No chimneys. Nothing remains of character of former smithy. Brick addition painted in brilliant white masonry paint.
8735	North Quarter House, Including Garden Walls, Main Street	Early 19th century 2-storey 3-window with single storey wing, arched roman doric pilastered doorpiece with good fanlight pended slated roofs.	B

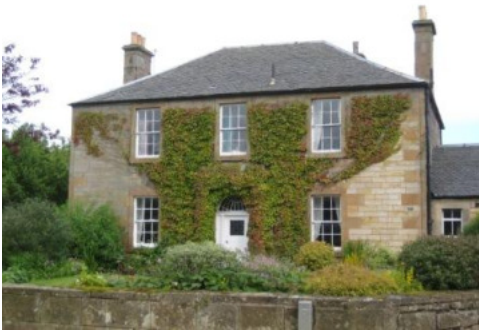
Recent vehicle impact damage to quality ashlar front boundary wall.

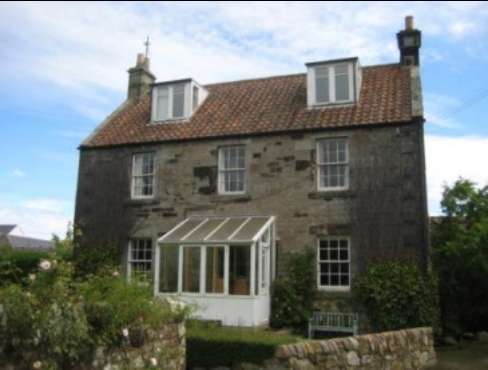
Dormer windows not mentioned in 1971 listing description.
8747	Former Bakehopuse, Torrie House, off Station Road	Early 19th century. L-plan, small 2-storey with forestairs, piended angle to roof.	B

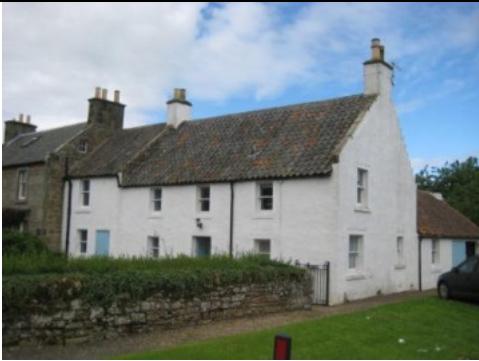
Modern cement render and brilliant white masonry paint.

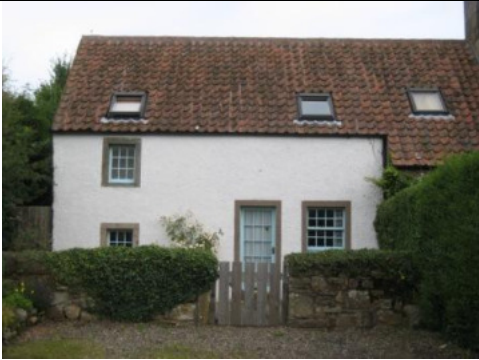
Restored to residential use with a new pantile roof. Fully glazed front door and large 'Velux' type roof lights. Brilliant white modern masonry paint over cement render.

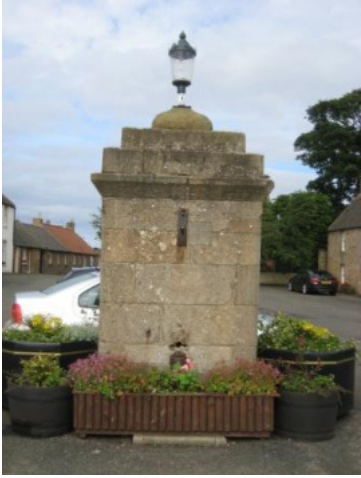
Modern "heritage" lamp.
8713	School House, The Square	John Corstorphine 1797. Plain 2-storey 3-window, harled with margins, fanlight doorpiece; wallhead chimney, crowstepped to rear at E gable.	B

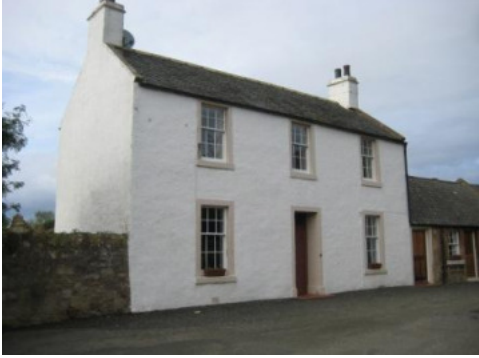
Satellite dish on roof. Brilliant white modern masonry paint.

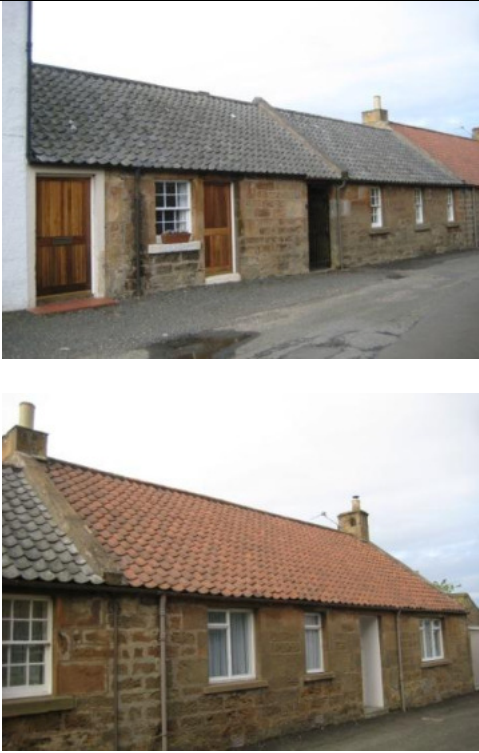
Middle cottage now slate roofed. Stella Maris windows to be replaced with traditional timber sash and case ones shortly. Varnished doors.
------	---	--	------	---	---

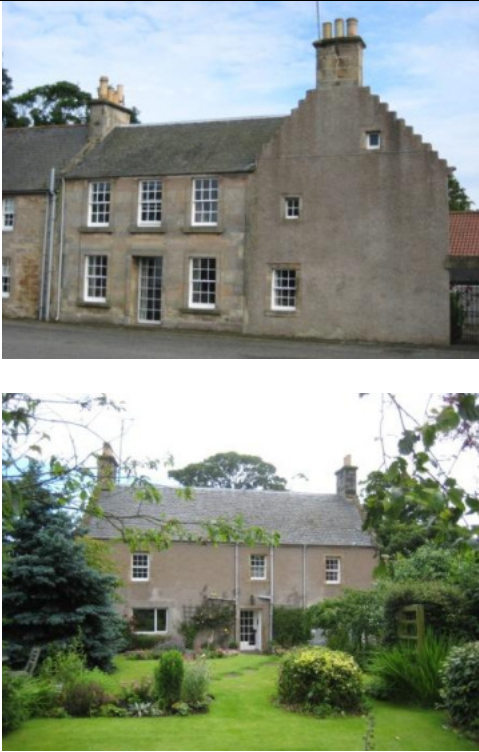
The Square elevation door fully glazed as a window. Main house elevation has enlarged modern window and fully glazed door.
8760	Cesneuk, The Square	Early 18th century. Plain 2-storey 3-window rubble pantile and crowstepped to rear, slated to front. Restored 1955.	B

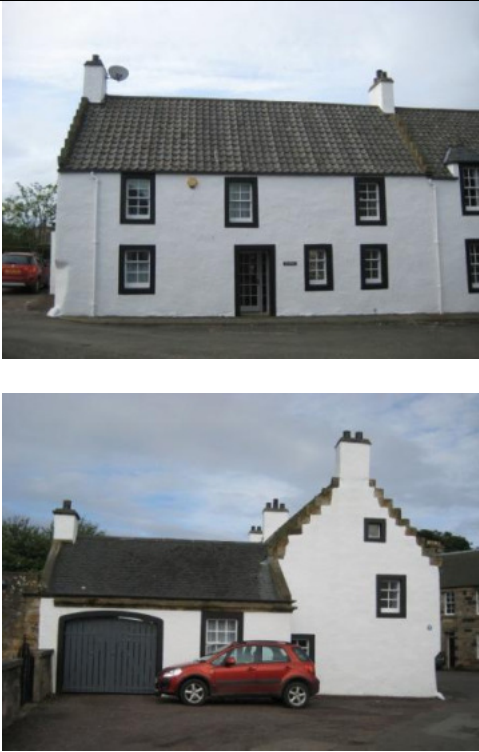
Satellite dish on roof. Restored by National Trust for Scotland. Modern cement render and brilliant white masonry paint.
------	---	---	---	---	--

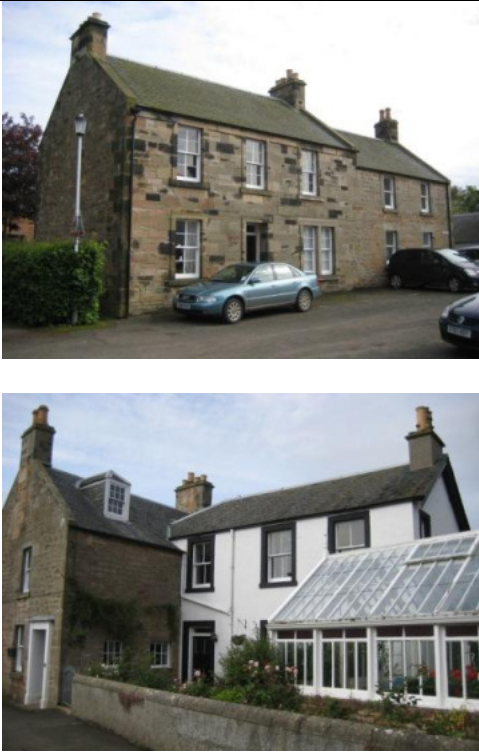
Brilliant w hite modern masonry paint to back w ing.
------	----------------------------------	--	---	---	--

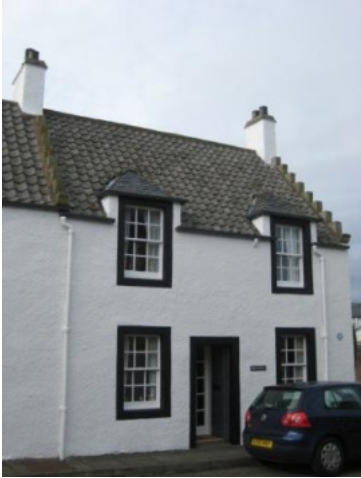
Brilliant white modern masonry paint over cement render.
8777	Former Joiner's Shop now Farm Store of South Quarter Farm	Mid 19th century. Single-storey and loft, rubble with pantiled double ridged roof, slate skirting.	C(S)

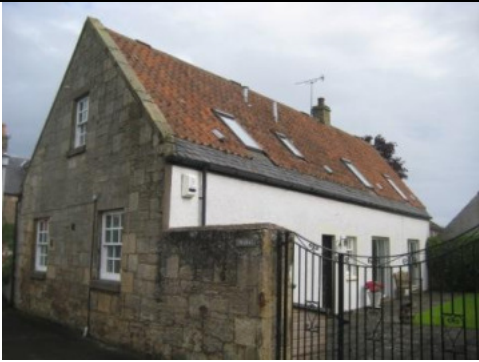
Converted to residential use. New pantile roof with unusual non traditional slate easing course and to gable skew cope detailing. Brilliant white modern masonry paint over cement render. Large 'Velux' type roof lights. Security alarm and domestic style wrought-iron gates.

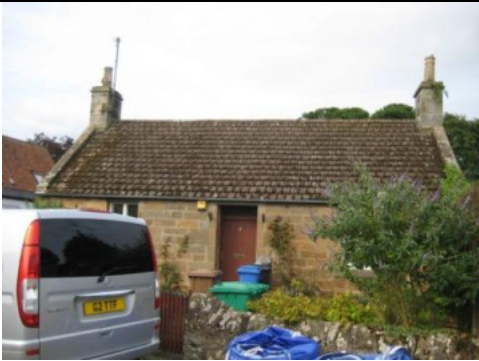
Concrete tiled roof.
8778	4, 6 and 8 Lady Wynd	Dated 1 PCS 1732 at lintel and 1794 at skew-end. Row of 3 single-storey rubble and pantile cottages, modern additions at back.	B

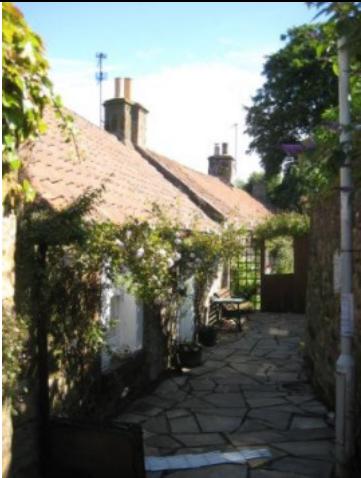
Rear of cottages much altered with loss of character and significance.

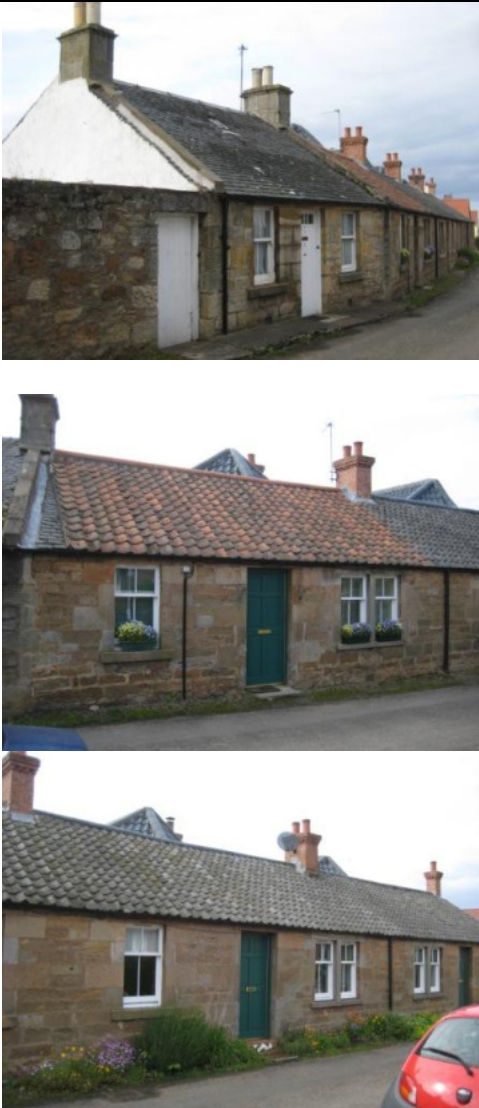
Large modern additions to rear. Satellite dish and TV aerials.
------	--------------------------------------	--	------	--	--

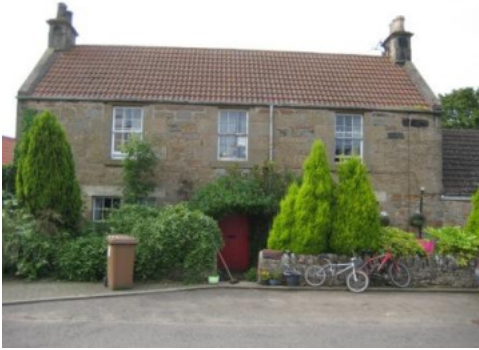
Poorly maintained. Blocked gutter and bare wood to windows.
8775	Cottages (Findlay and Hill), Lady Wynd	Early 19th century. Single-storey pair, 2-windows and 2 centre doors, projecting piended out-building partly lean-to at E gable rubble and pantile.	C(S)

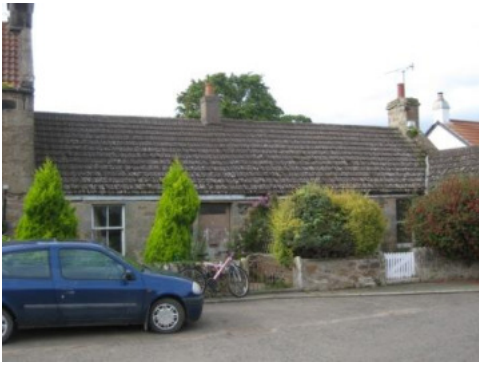
Concrete tiled roof. Poorly maintained. Bare wood showing to windows and door.

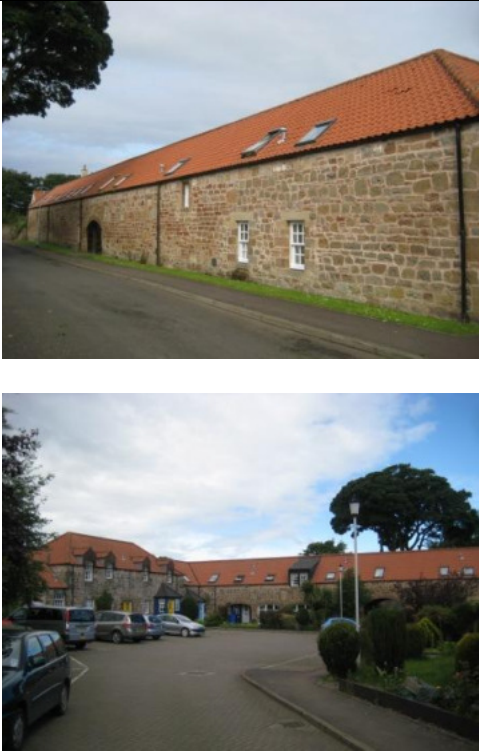
Converted to residential use with some loss of historic steading character.
8738	South Quarter Farmhouse	Dated 1786 at skew. Plain 2-storey 3-window ashlar and slate with moulded eaves cornice and later 2-storey wing, modern porch. Slated.	B

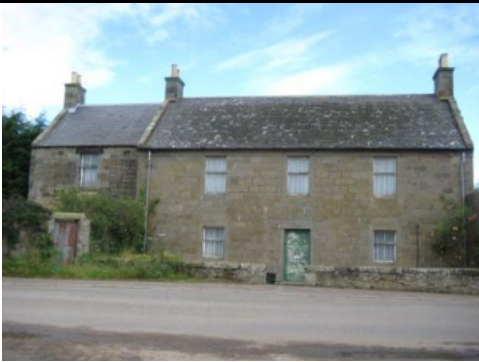
Remains in farm related but non-residential use. Largely as original but potentially at risk.

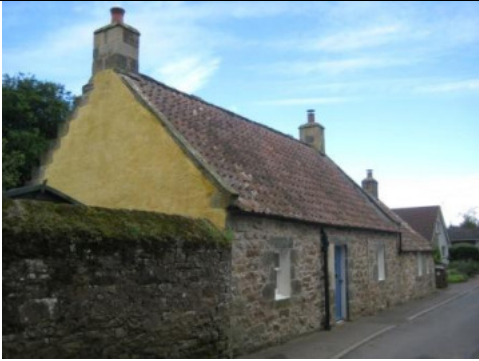
Traditional lime harl and colour wash.
8745	Retreat Cottage, Bells Wynd	Circa 1800, former croft. Single-storey coursed rubble and slate, 2-w indow and centre fanlight door house and short steading section w ith loft w indow one roof.	B

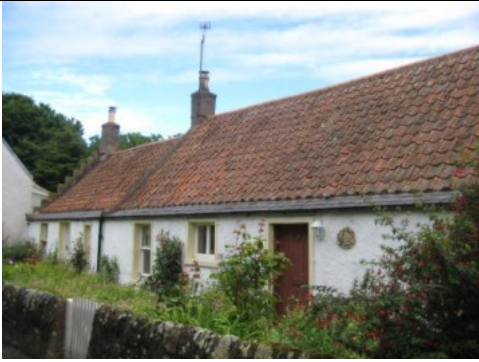
Brilliant white modern masonry paint over cement render.

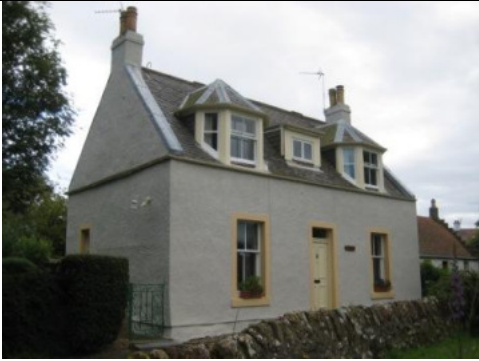
Modern masonry paint over cement smooth render and non-traditional colour scheme.
8742	The Old Forge, Including Garden Walls and Garage, North Street	Dated DA HM at scrolled skew-put with cable moulding. Single-storey, originally 2-w indow and centre door (now built up as window) large droved squared rubble and pantile, modern dormer. Garage part of former smithy.	C(S)

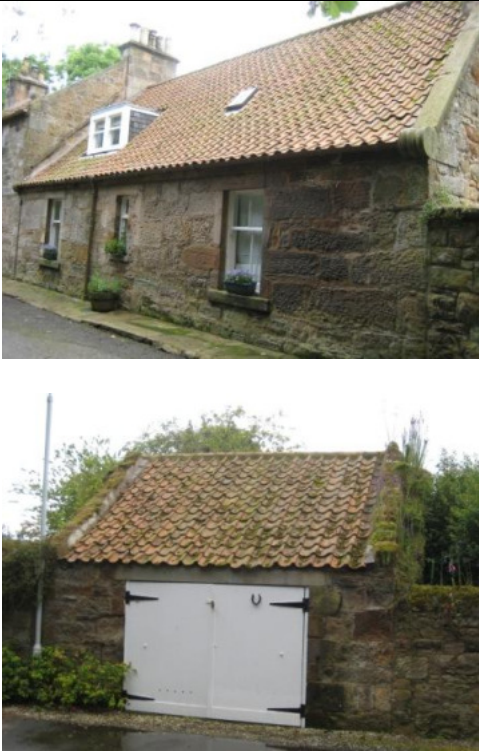
Dormer window addition. White modern gloss doors to former smithy. Skew put dated 1792.

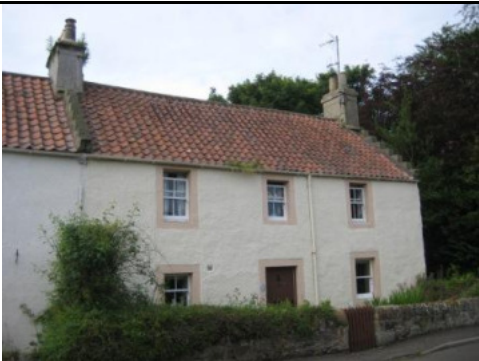
More sympathetically painted off-white masonry and neutral margins.
